Situation Photo Log

Friday, February 15, 2013

Kalamazoo River / Enbridge Spill

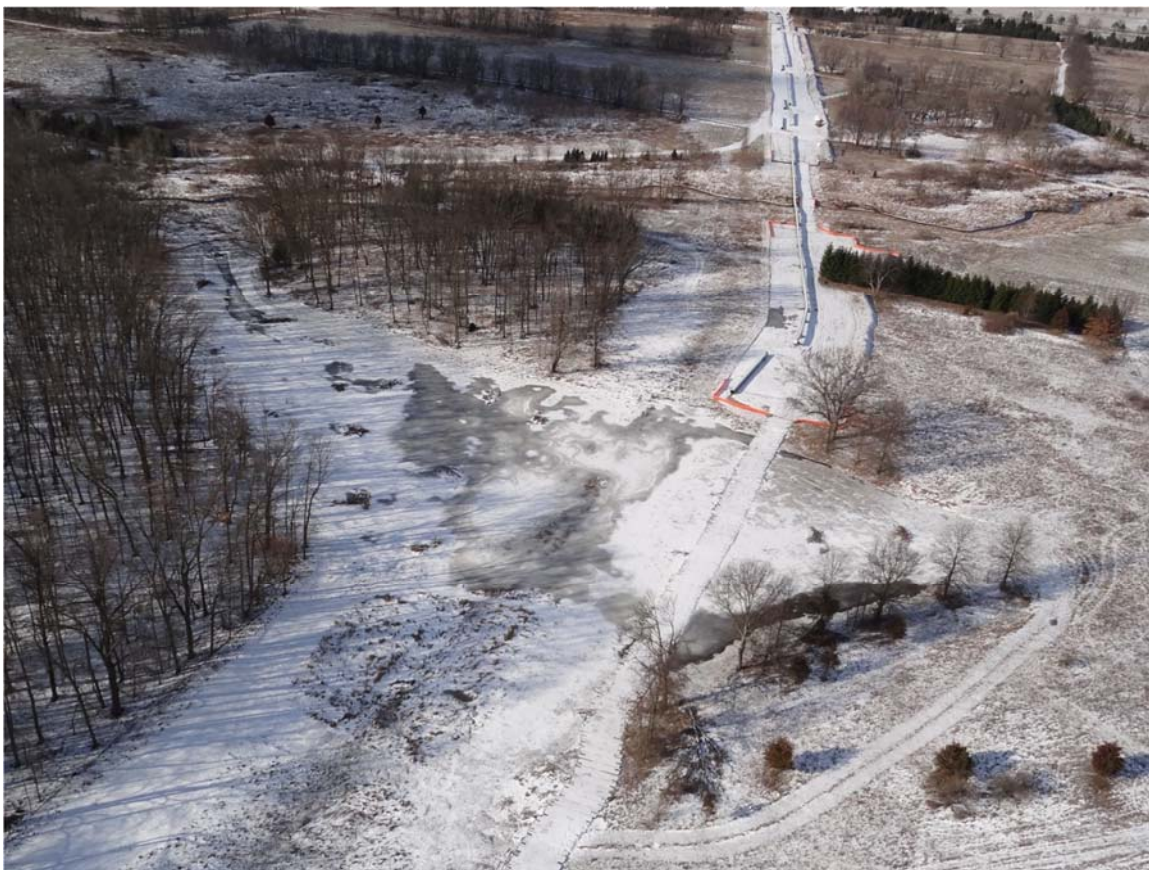
1. Source Area, observed frozen over.

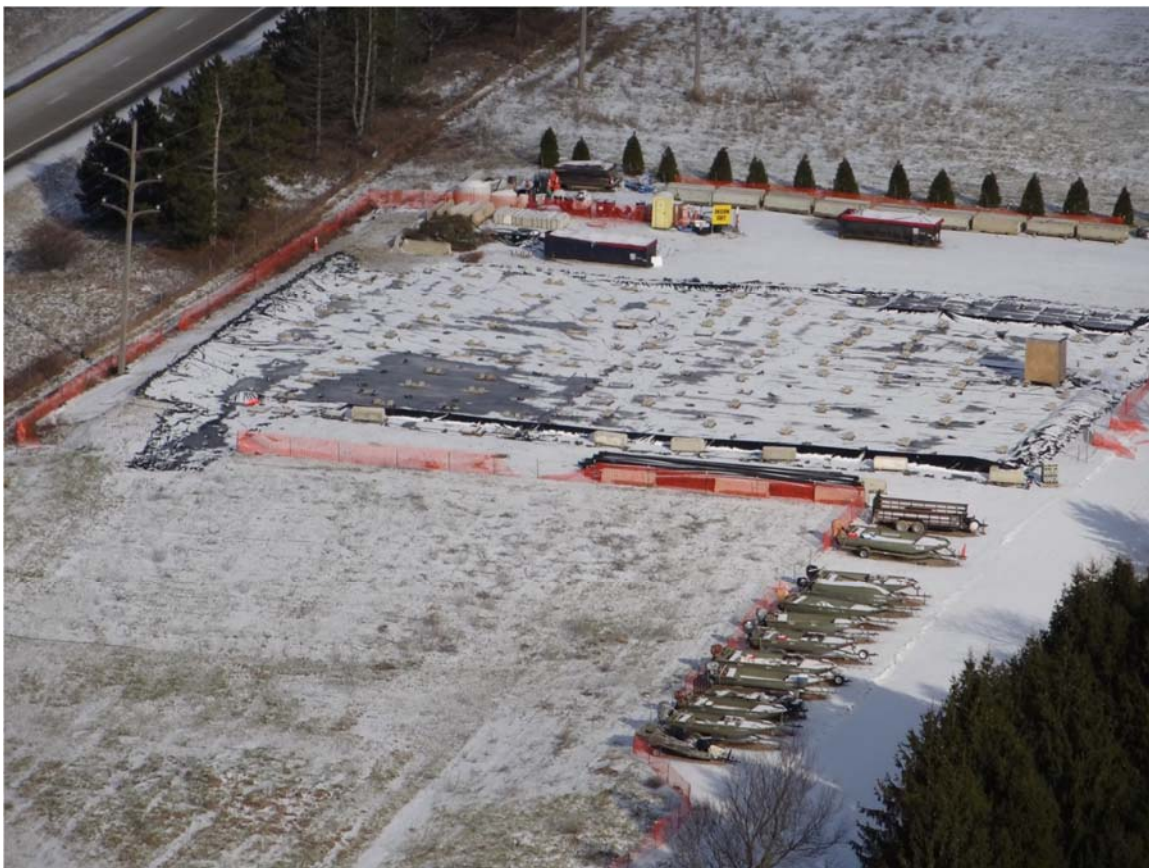
2. Frac Tank City observed Cells A/B winterized.

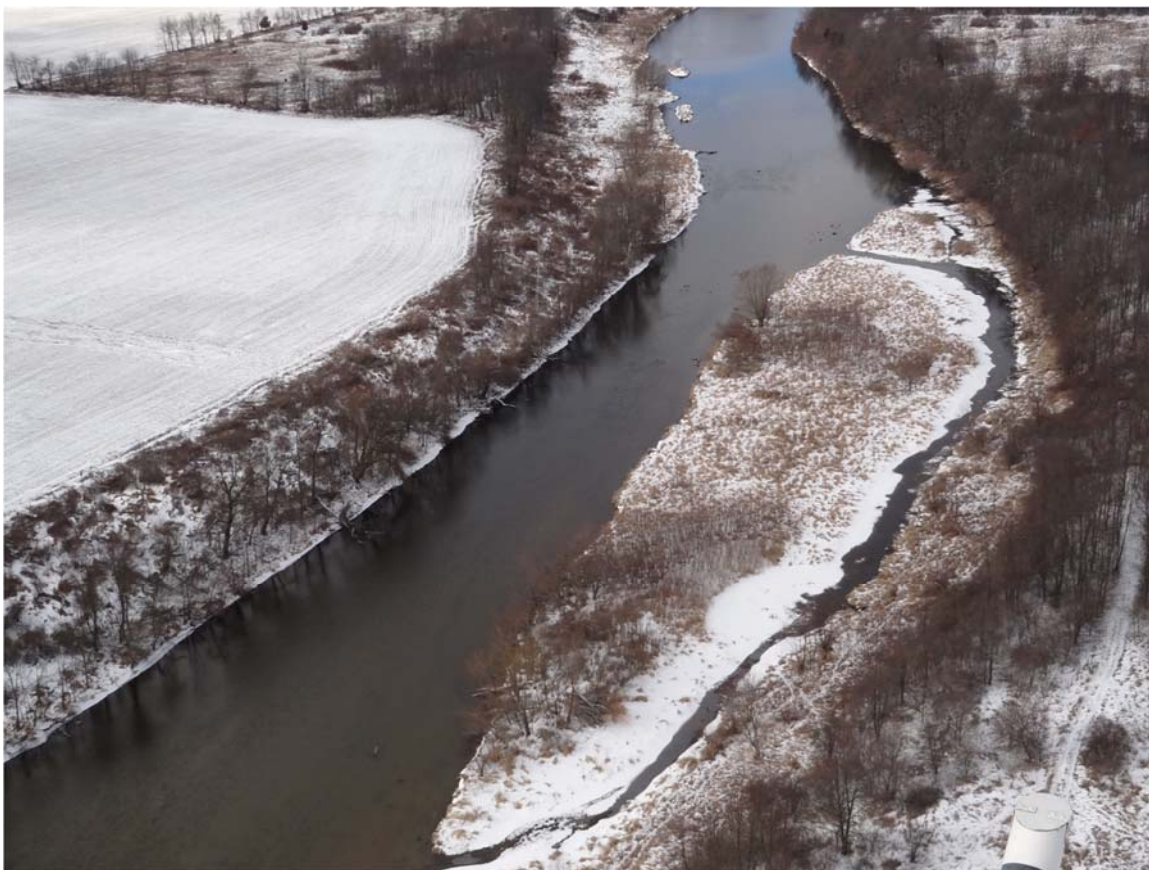
3. MP3.75 observed increased river level conditions.

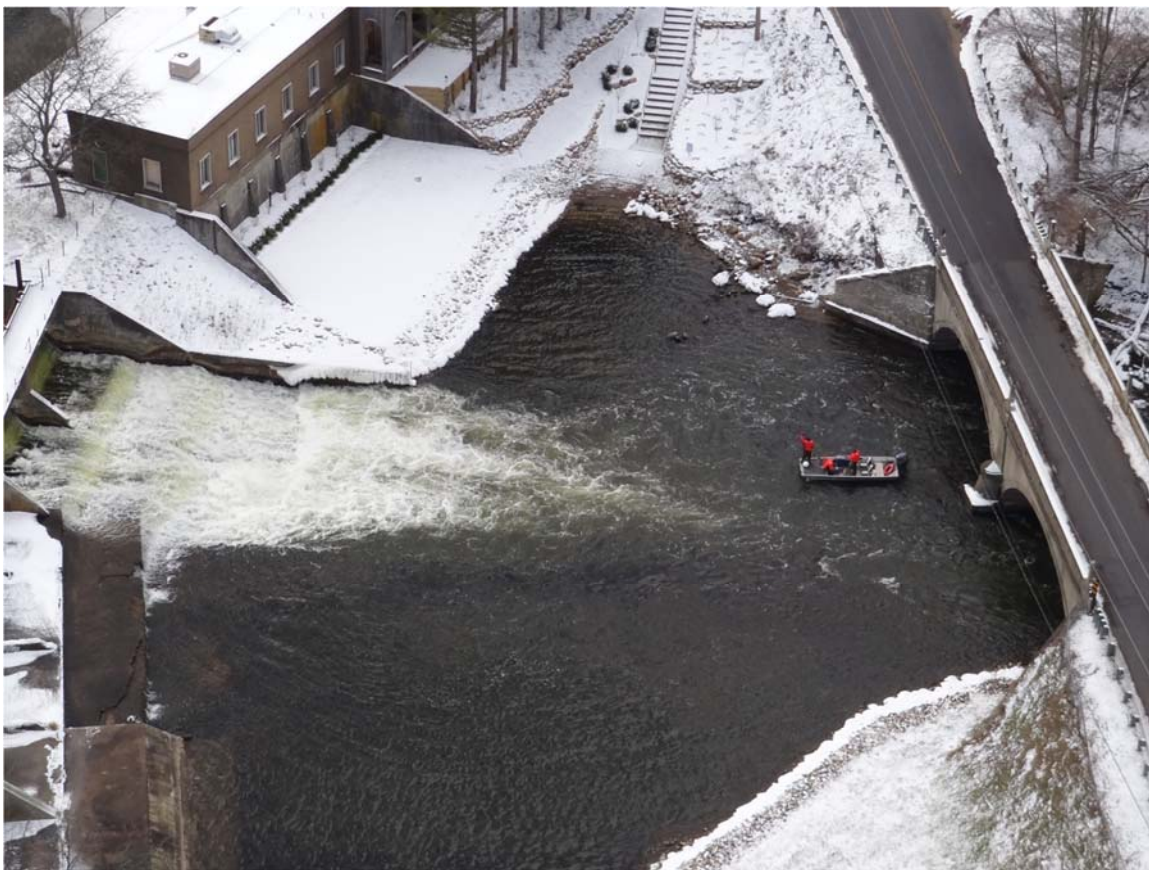
5. Ceresco Dam observed a crew retrieving a CSD sampler.

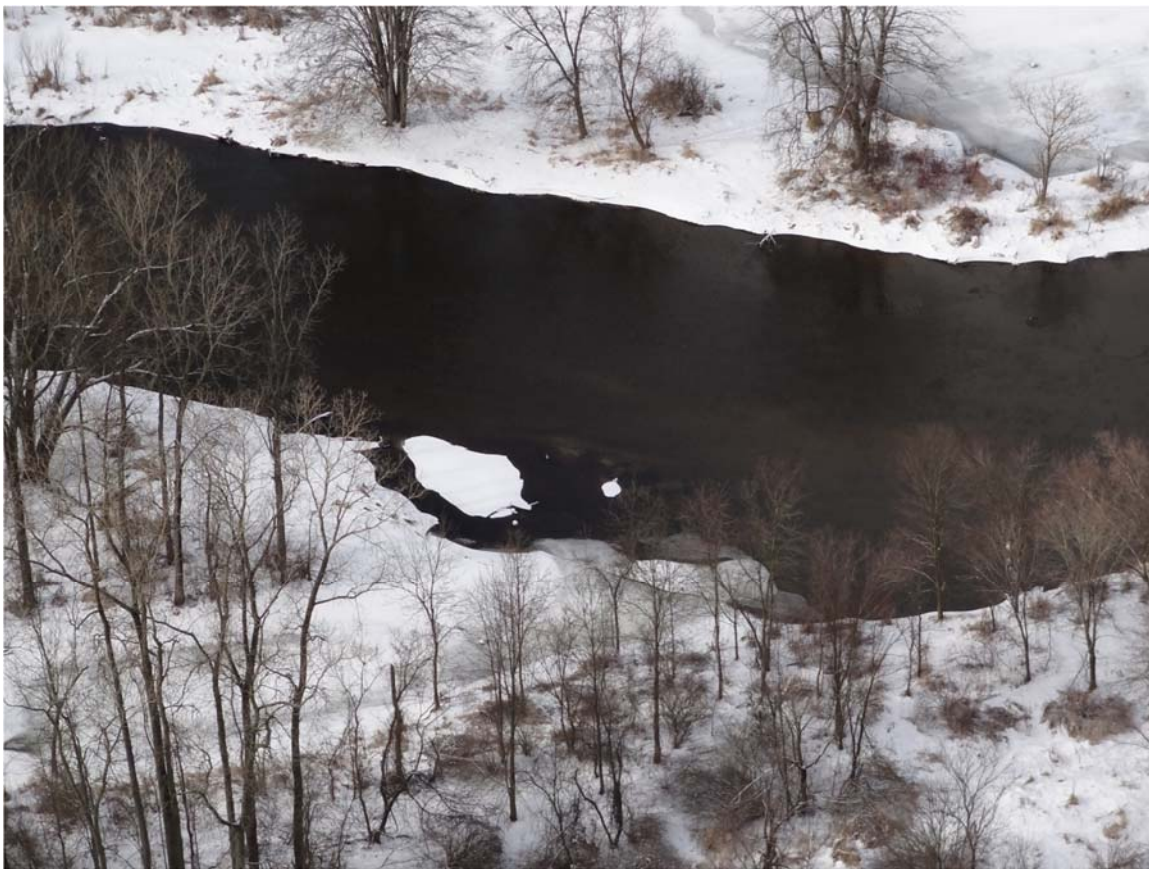
6. MP10.4 RDB Sediment trap ice conditions.

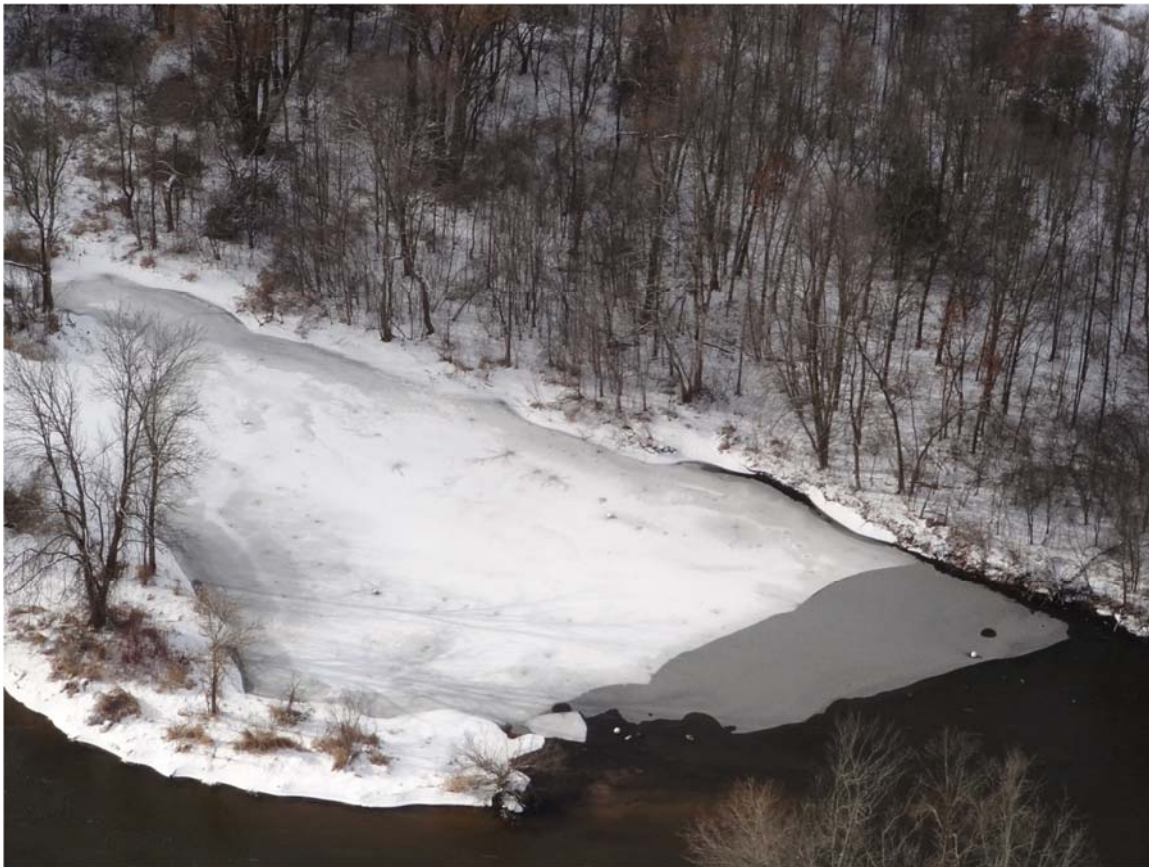
7. MP10.5 LDB Sediment trap ice conditions.

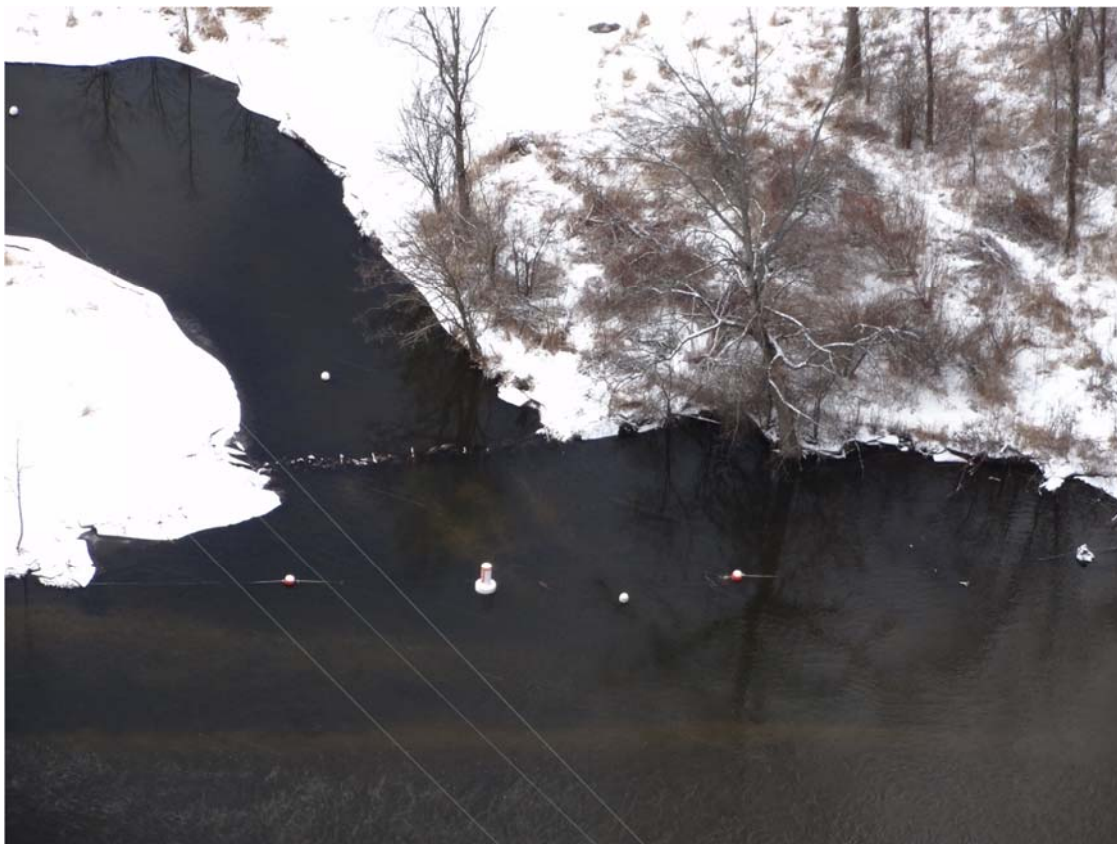
9. MP10.75 Sediment Trap observed repairs made to the conifer tree structure.

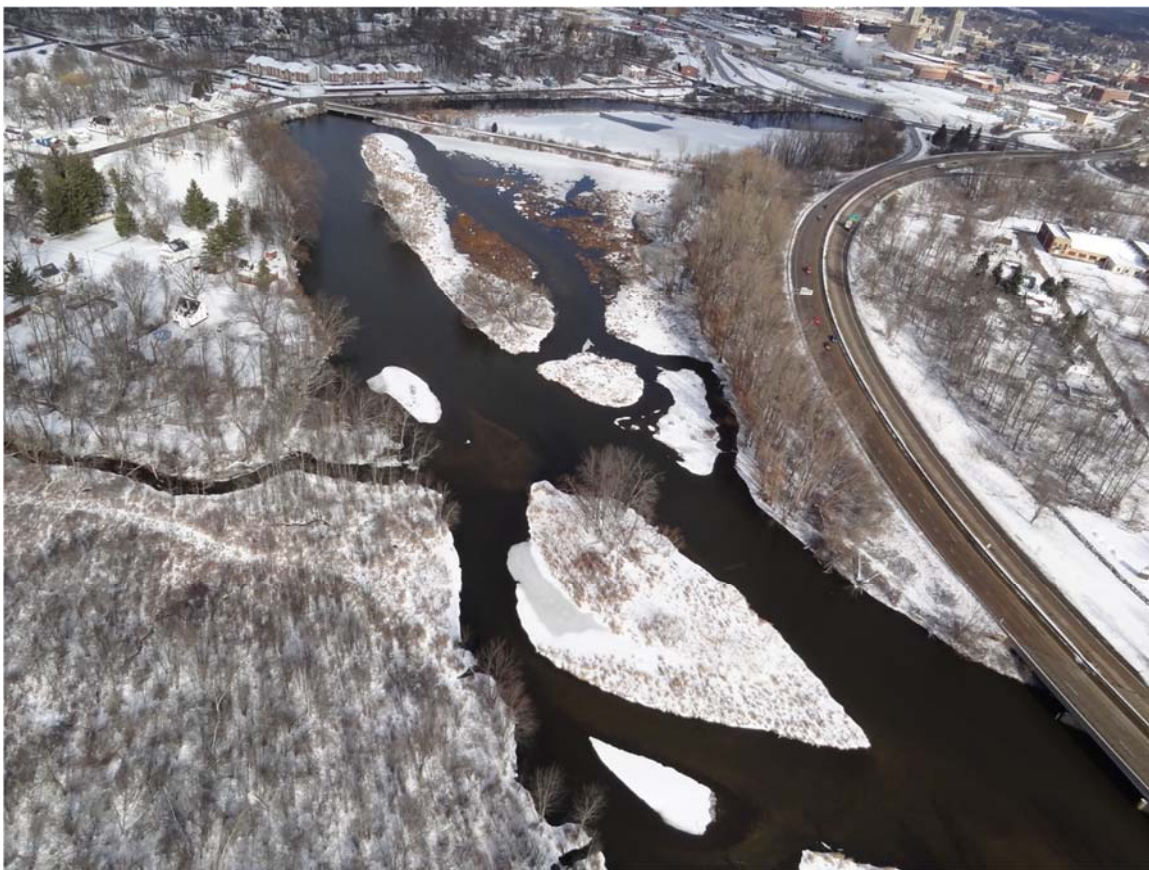
13. North and South Mill Pond icing conditions.

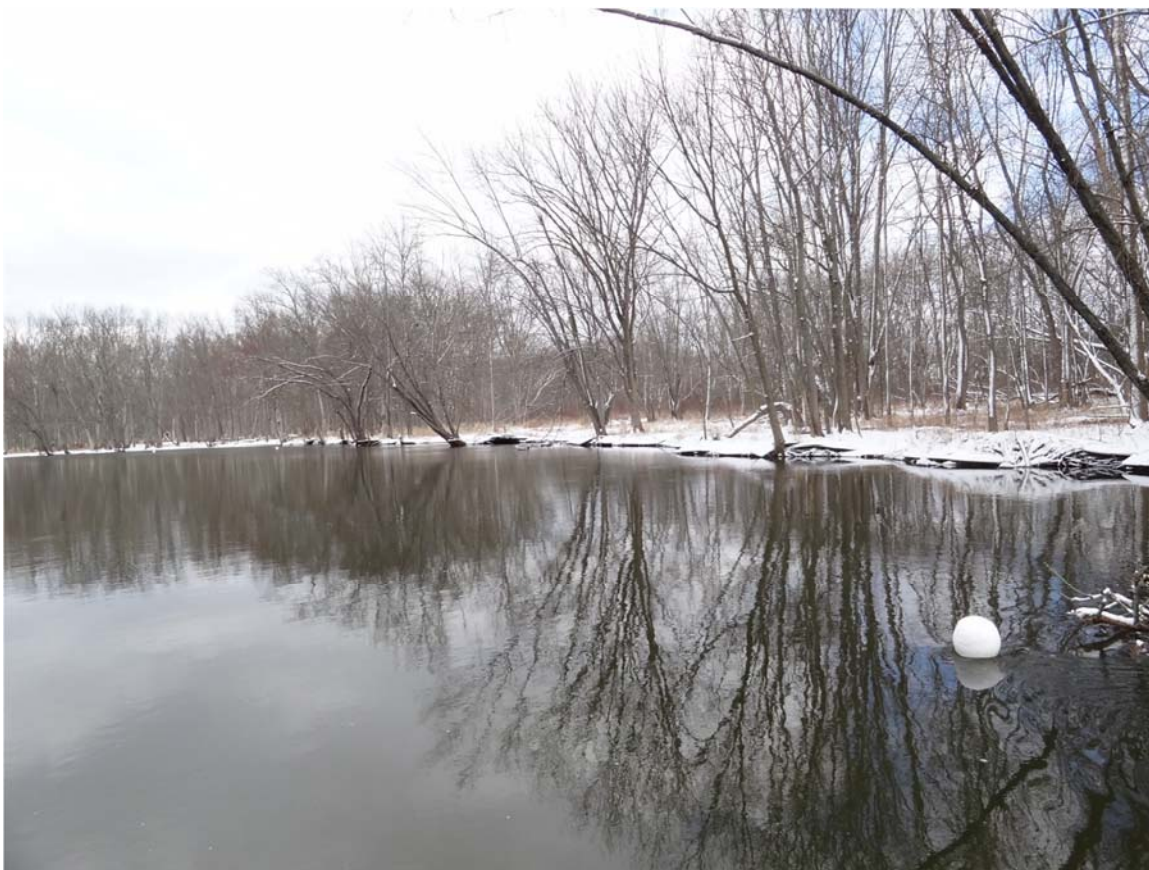
24. MP33.0 B Sediment trap CSD located approximately 75 yards down river from the sediment trap.

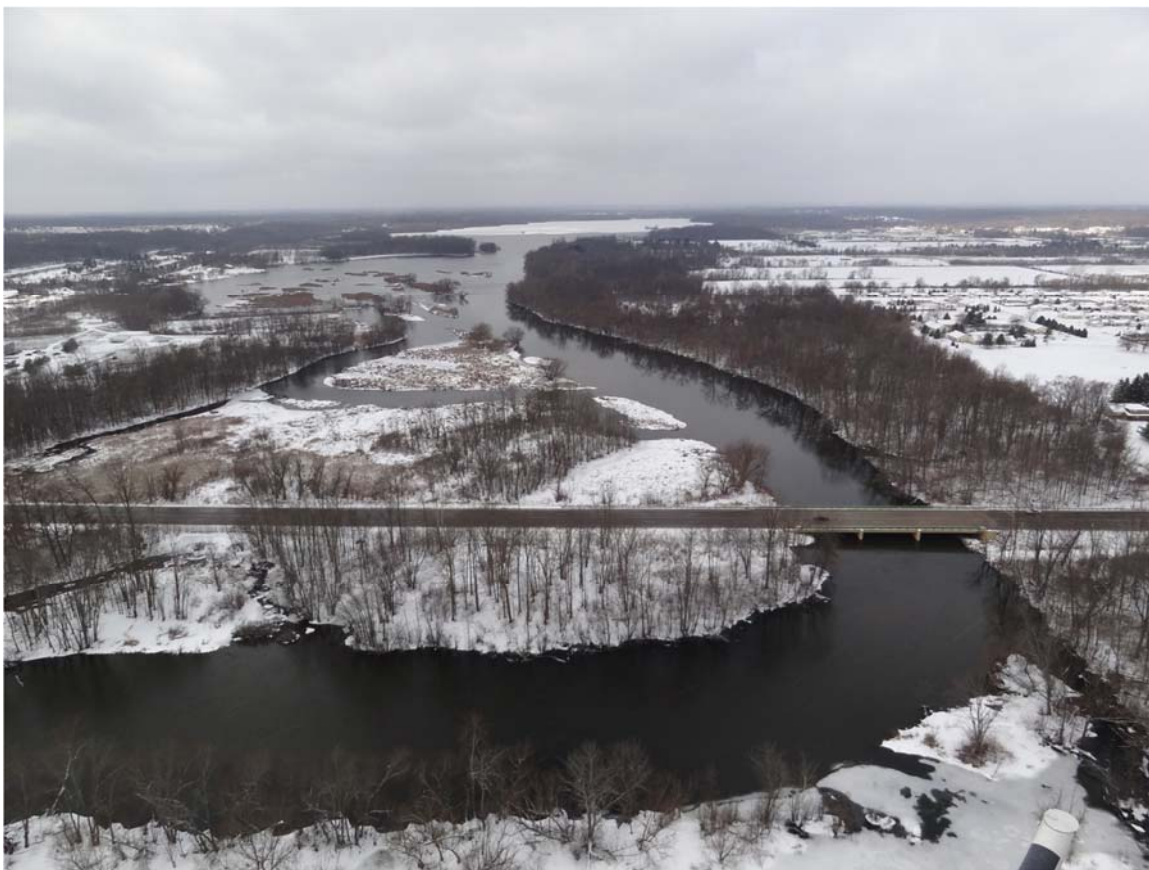
27. Morrow Lake Delta river icing conditions.

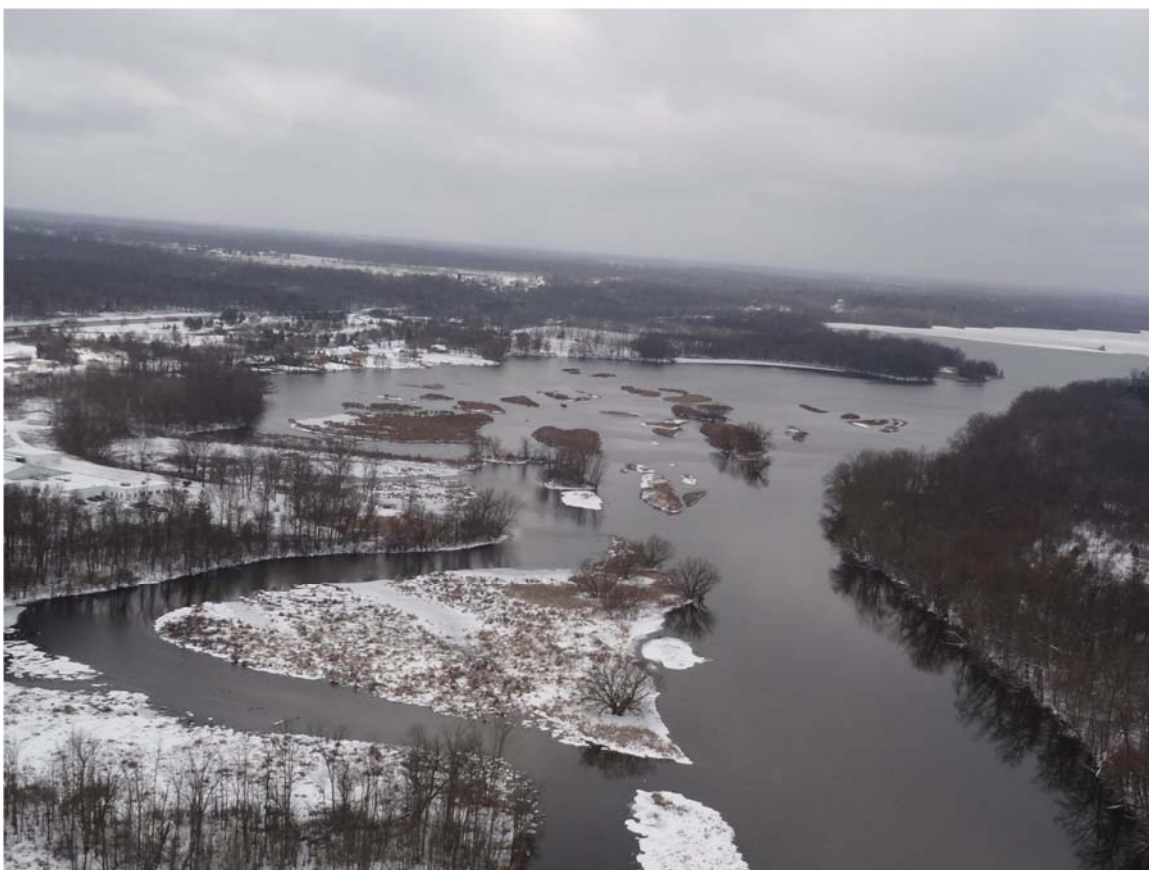
28. Morrow Lake Delta river icing conditions.

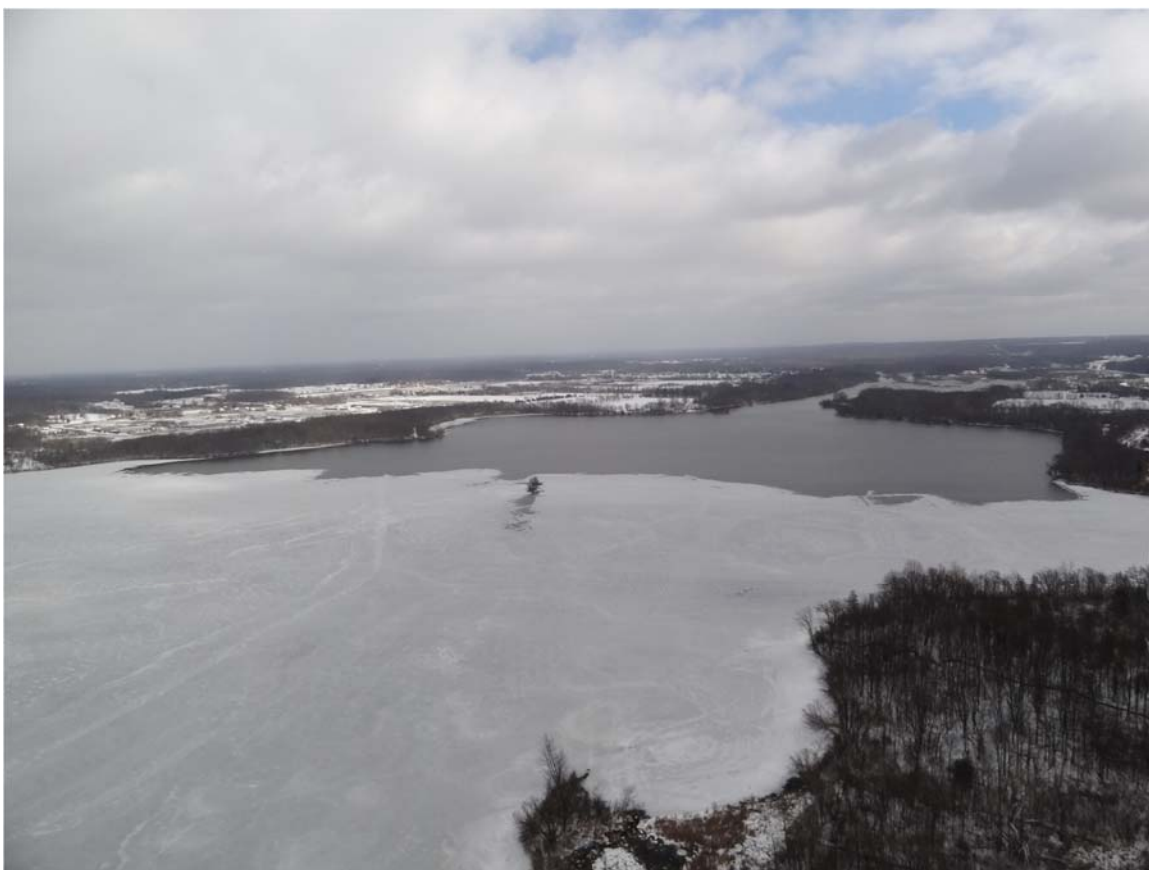
30. Morrow Lake icing conditions.

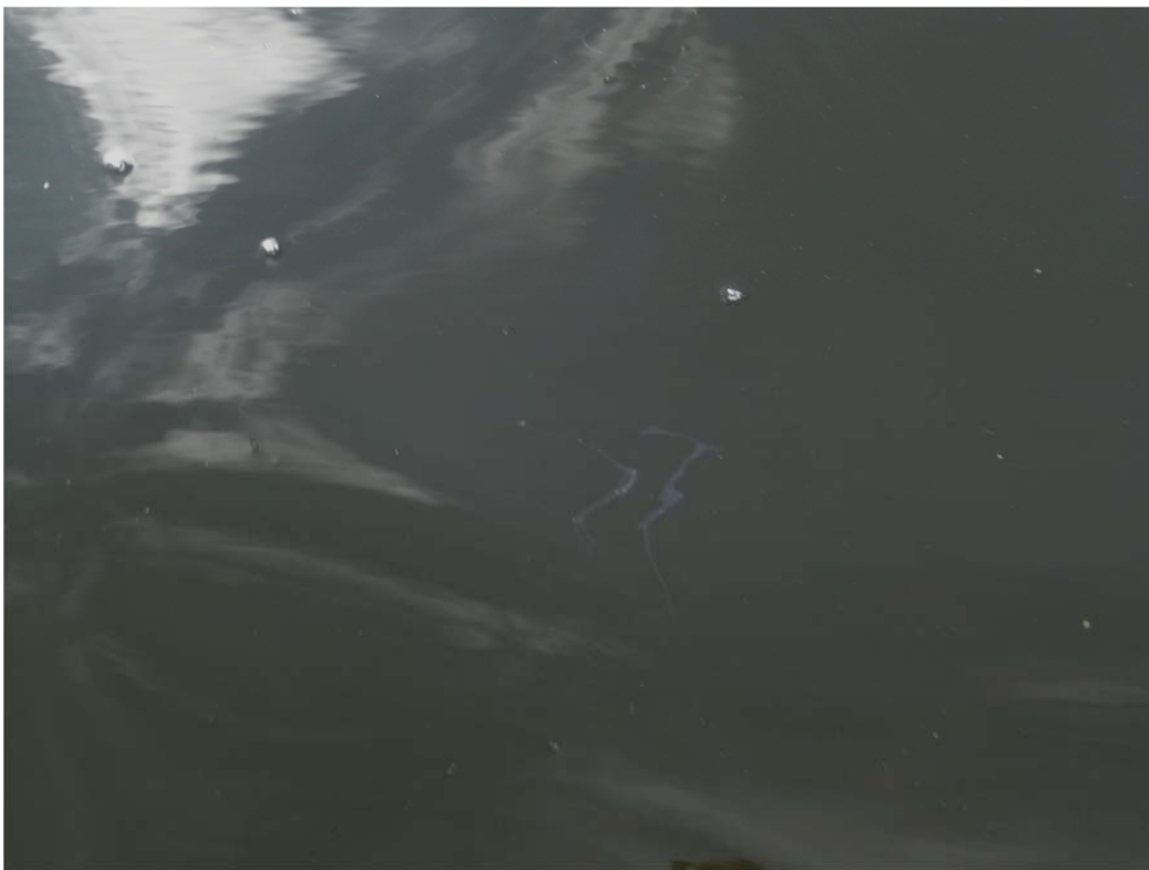
33. Morrow Lake Delta Neck observed sheen and tar globs.

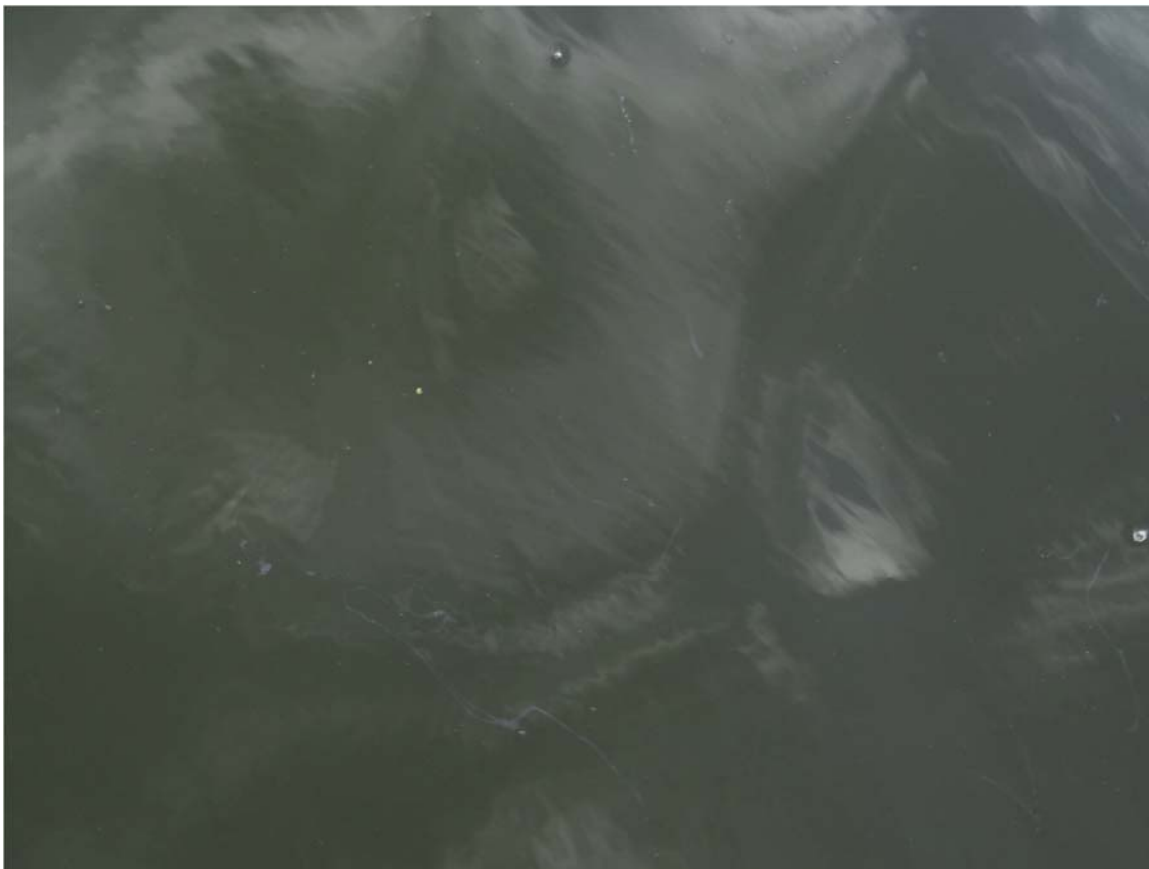
34. Morrow Lake Delta Neck observed sheen and tar globs.

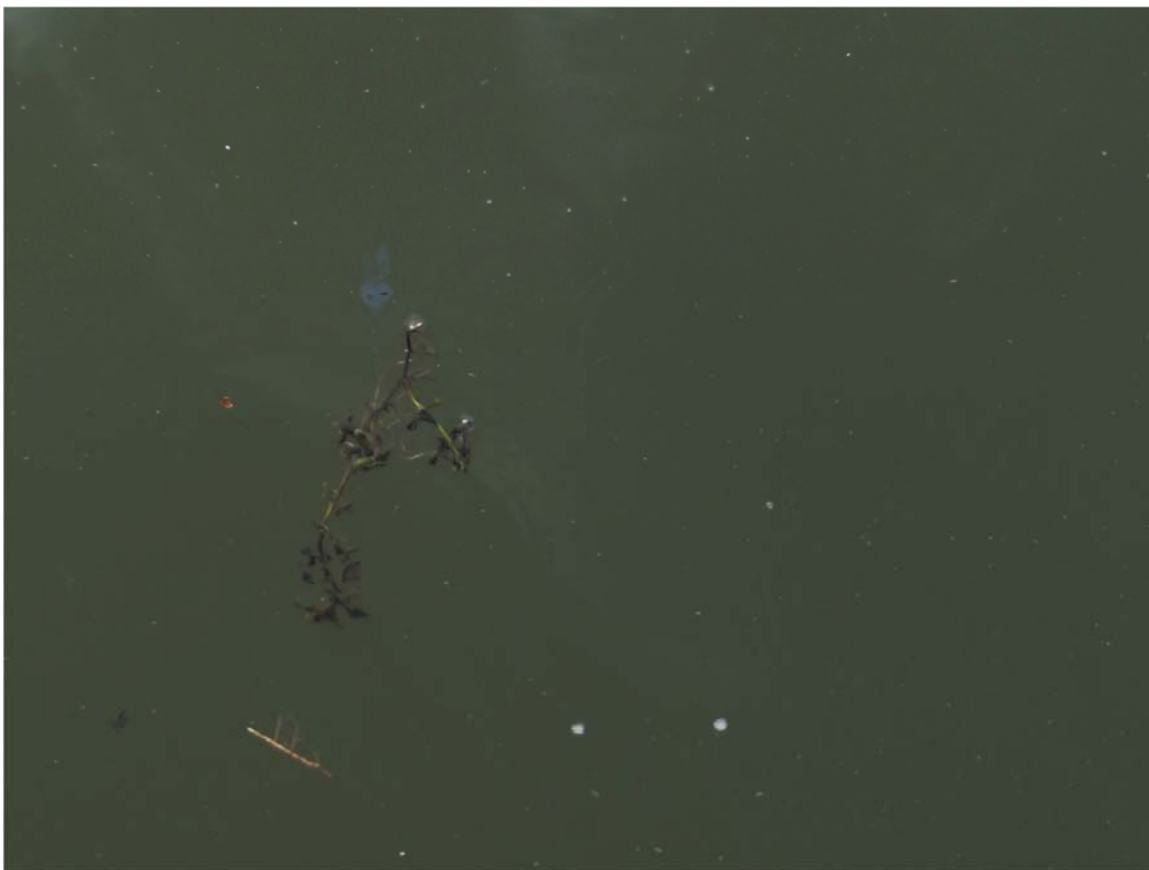
35. Morrow Lake Delta Neck observed sheen and tar globs.

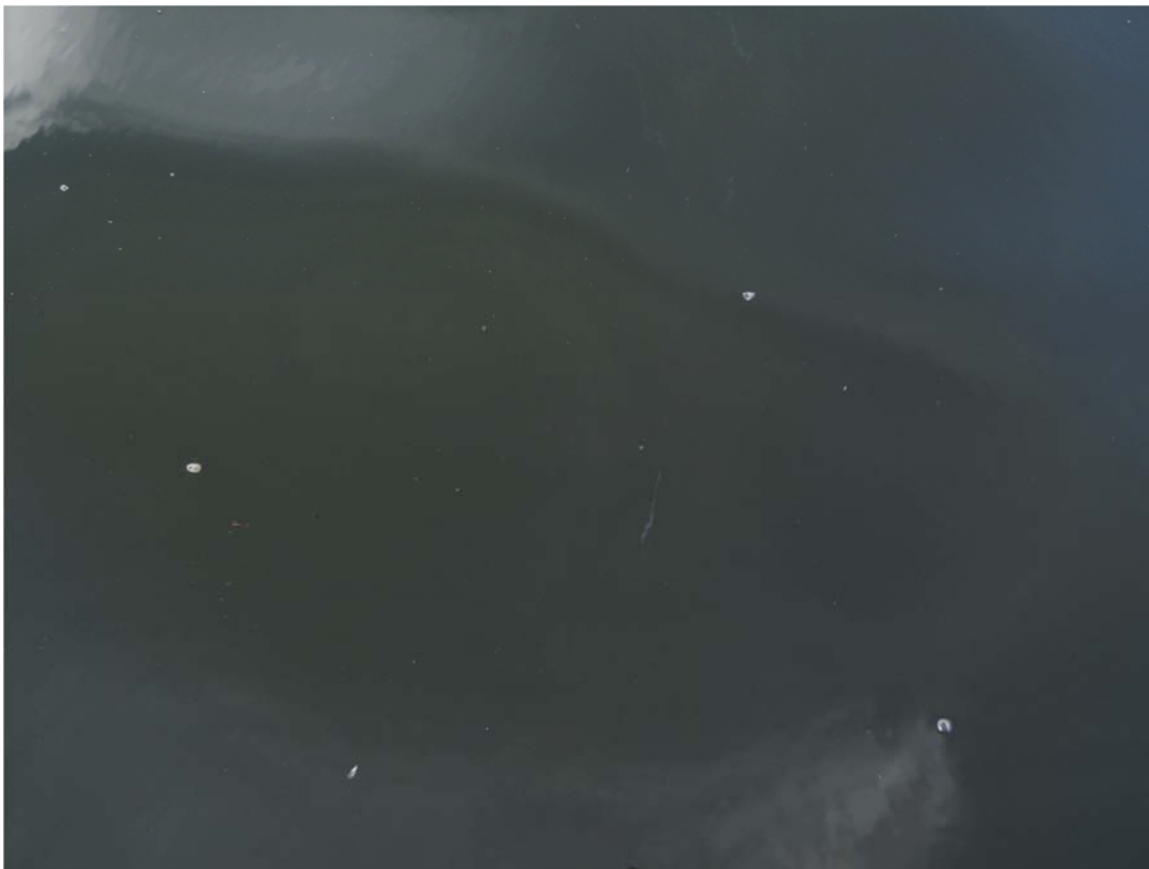
36. Morrow Lake Delta Neck observed sheen and tar globs.
